W76 GWR Collett CENTENARY RESTAURANT OPEN THIRD      Diag. H44

Introduced 1935, last withdrawn 1964      60'

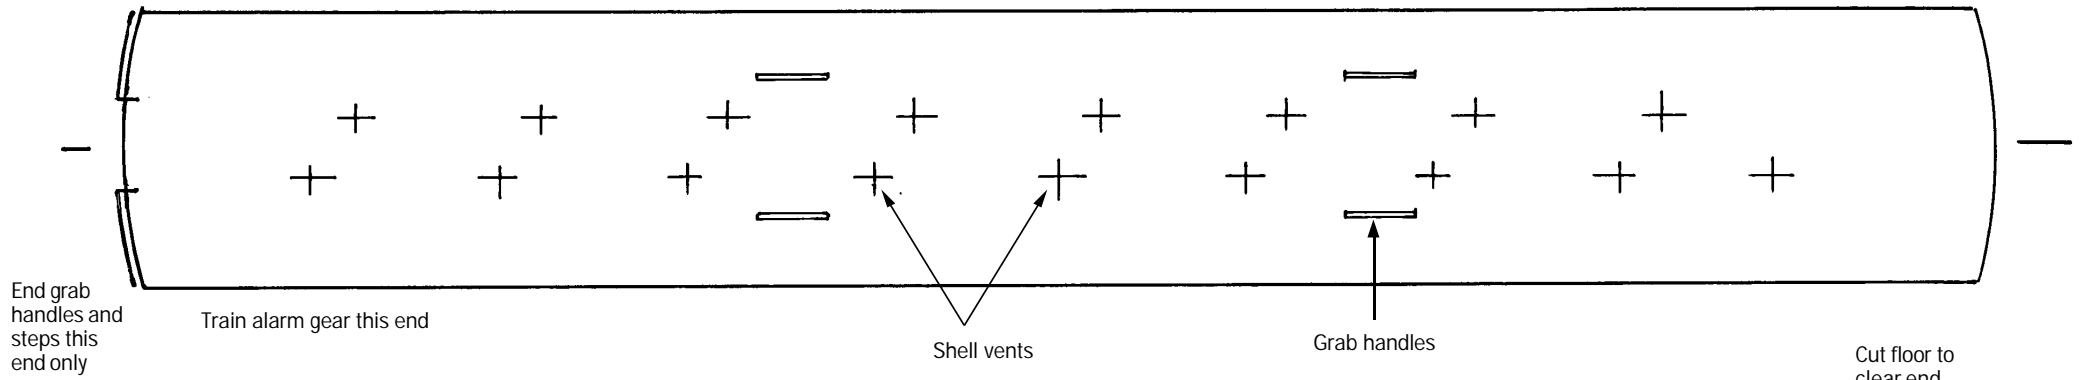
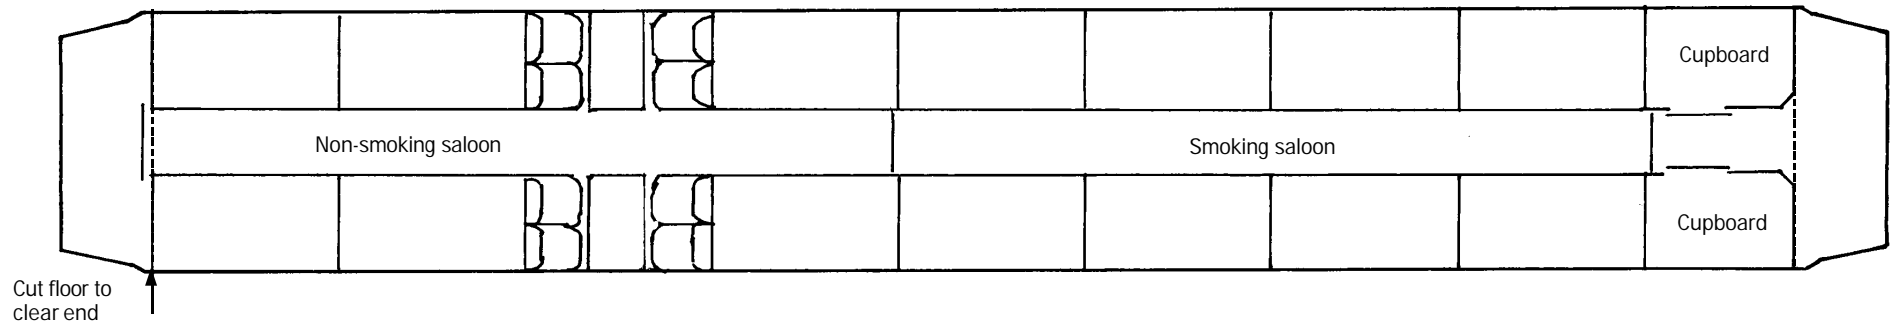
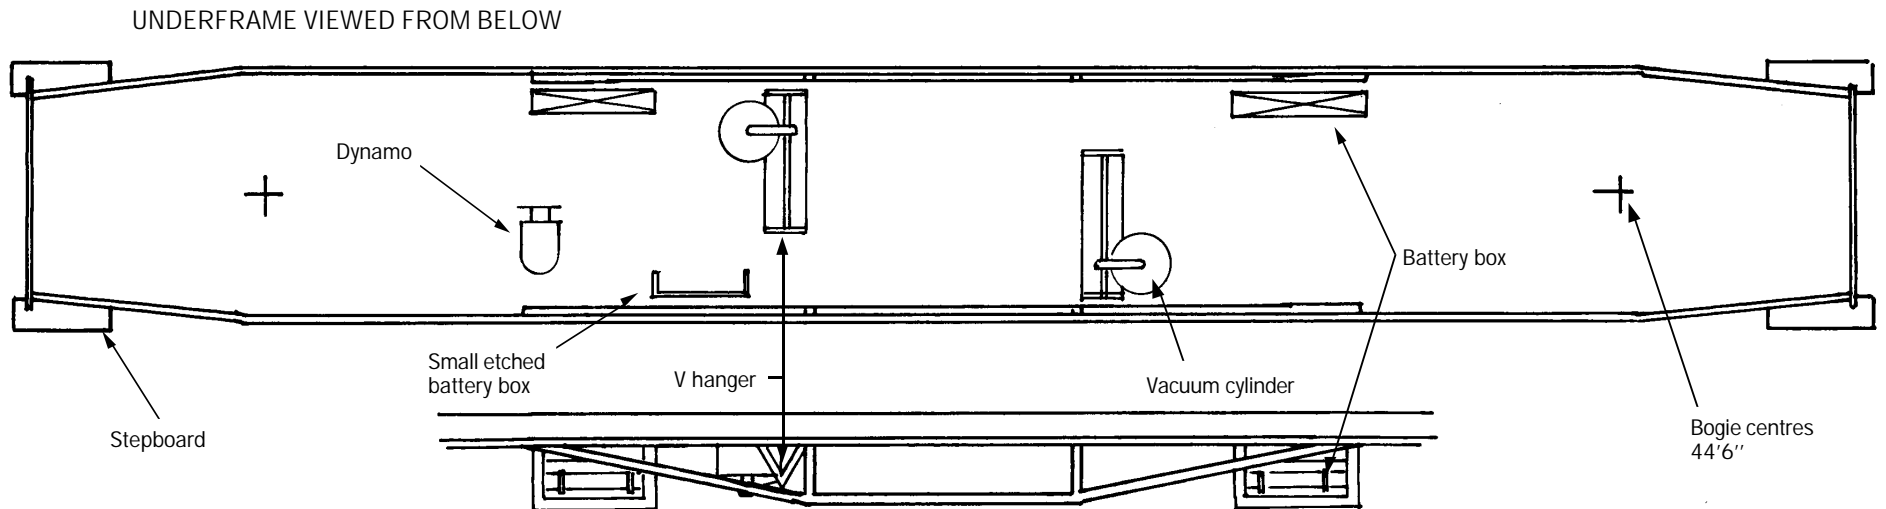
H44

Note that the train alarm gear, steps and filler pipes were present only at the end shown on the roof plan overleaf. The other end was plain.

This end of the coach was coupled to the kitchen end of Restaurant First H43
