M63 LMS Stanier OPEN BRAKE THIRD

D1913

Introduced 1934, last withdrawn 1965

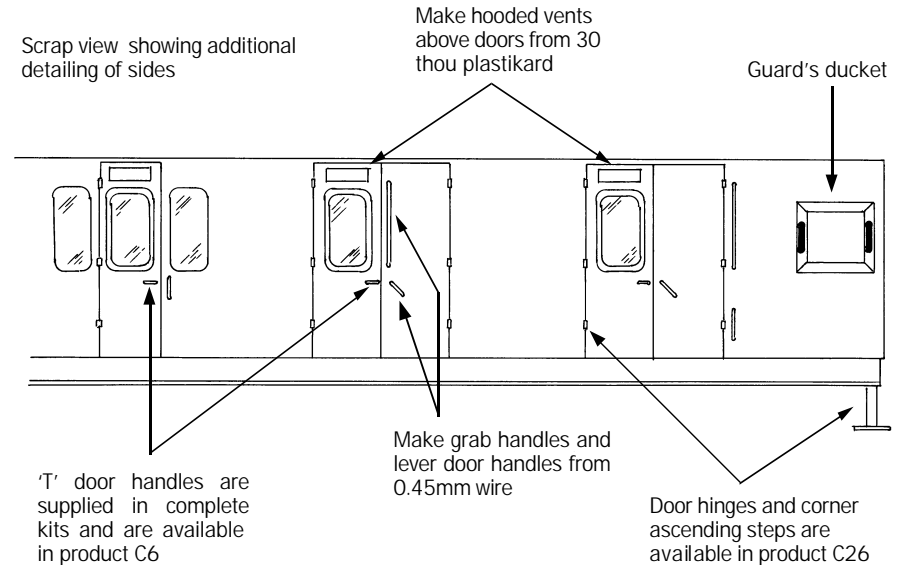
Train alarm gear this end

Guard's ducket
