## W72 GWR Collett CENTENARY CORRIDOR BRAKE THIRD L/H Van Diag. D120

Introduced 1935, last withdrawn 1964

These etched sides can be built into a complete coach using products from our range as supplied in our full kits. Please refer to the panel opposite. Should you prefer they can also be used to overlay the Hornby (ex Airfix) Centenary coaches, or as a basis for a scratchbuilt coach.

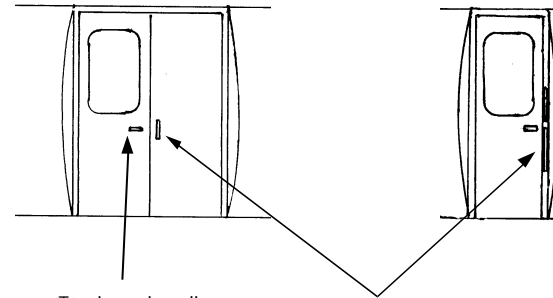
Scrap view of side showing inset luggage doors and guards door

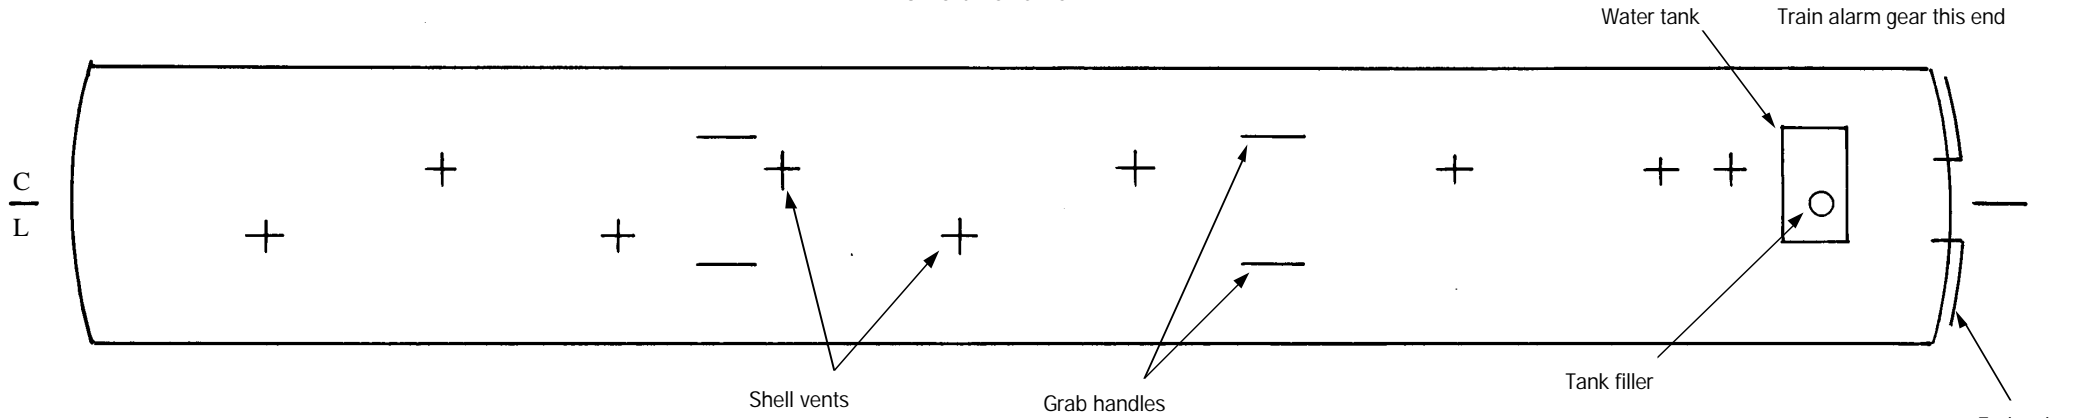
Note that the train alarm gear, steps and filler pipes were present only at the end shown on the roof plan overleaf. The other end was plain.

Make grab handles from 0.45mm wire
